LAKE LUDLOW CLUB DAM

CHENANGO COUNTY, NEW YORK
INVENTORY No. NY 350

PHASE I INSPECTION REPORT NATIONAL DAM SAFETY PROGRAM

NEW YORK DISTRICT, CORPS OF ENGINEERS
JULY 1981

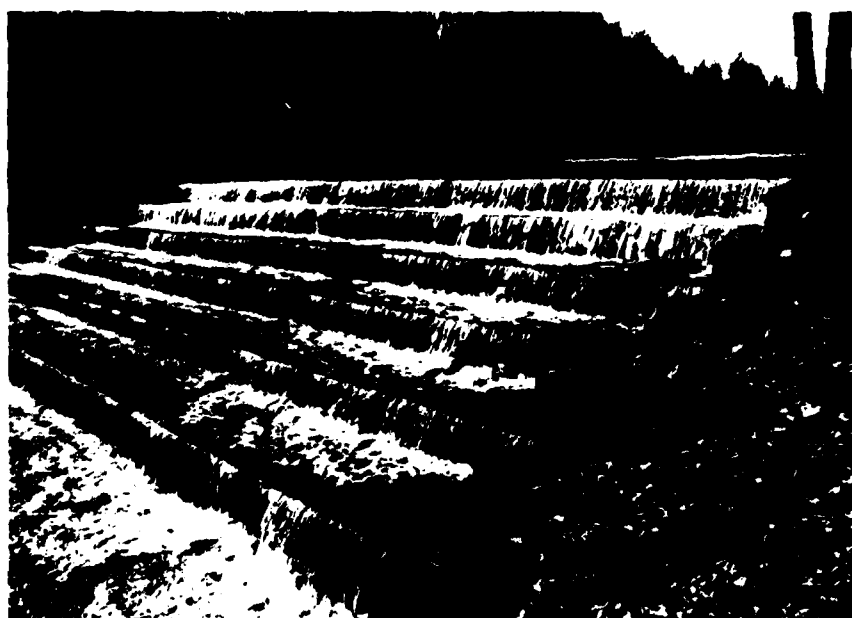
PHOTO #7: Downstream face of dam

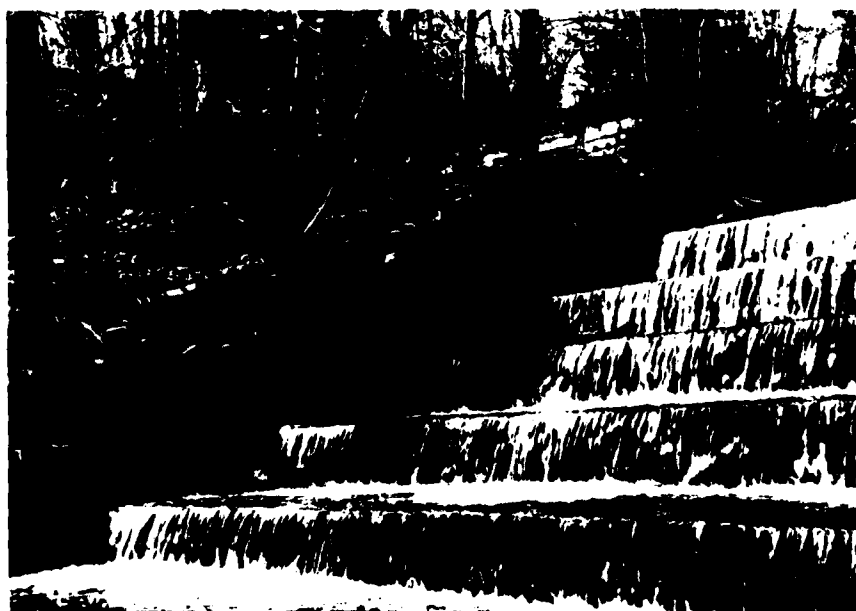
The dam has a short embankment section on each side of the overflow spillway (See Photos No. 8 and 9); these embankments are generally in fair condition. The irregular configuration tended to obscure any evidence of lateral movement or settlement, but there was some local erosion and possible seepage.

PHOTO #9: Stepped concrete retaining
wall on right side of spillway

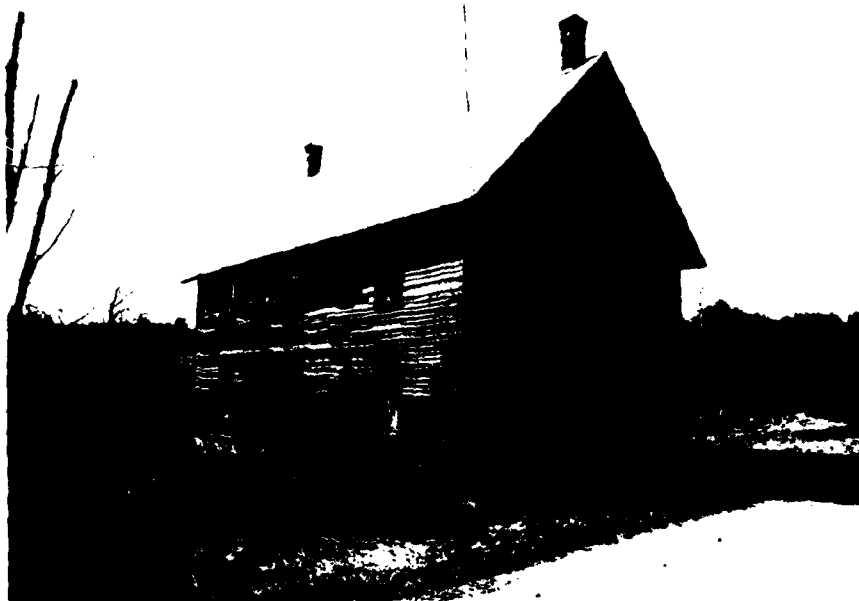
PHOTO #16: Reconstructed church in Tyner which
was washed away by 1935 flood

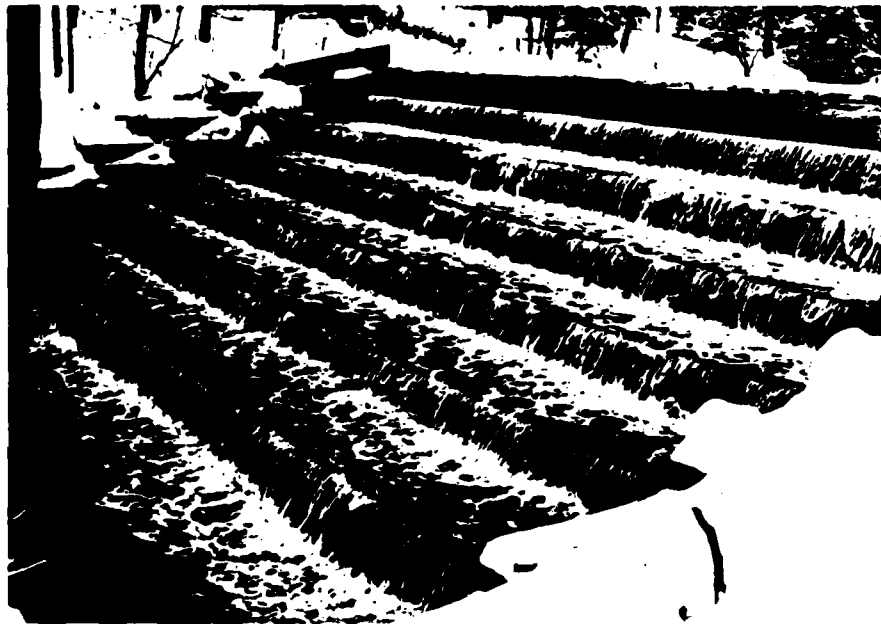
PHOTO #1: Downstream face of dam

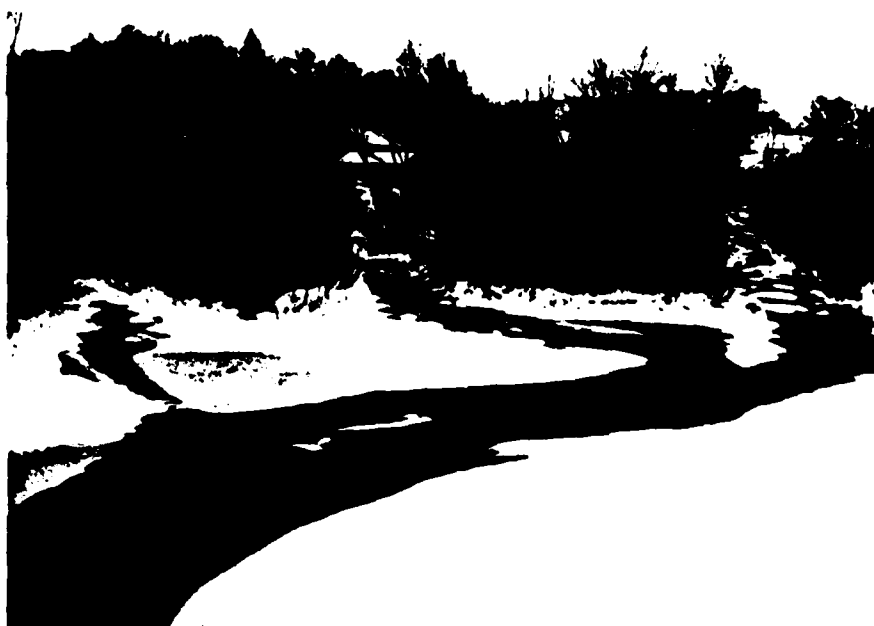
PHOTO #4: Upstream view from bridge (See
Flood Impact Map - sheet 2 of 2)

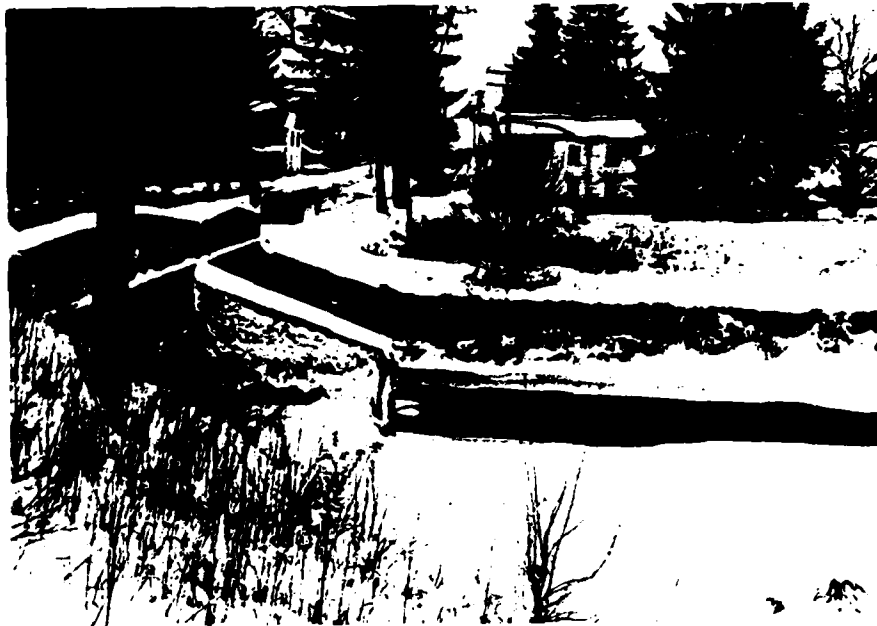
PHOTO #5: Upstream face of bridge (See Flood Impact Map - sheet 2 of 2)

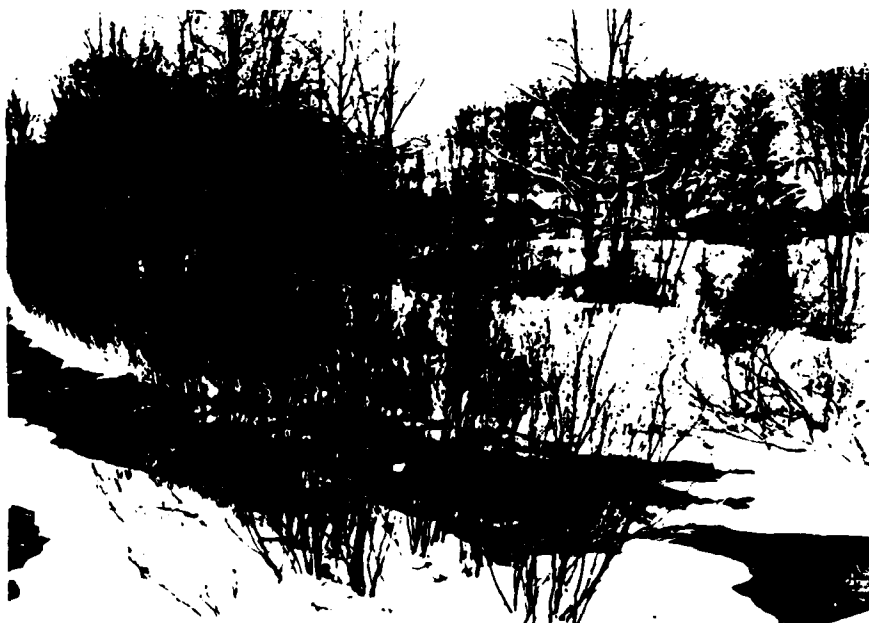
PHOTO #6: Downstream view from bridge (See Flood Impact Map - sheet 2 of 2)
